## Case 239 : Narrative

Case Vehicle (A): 2000 Mercedes-Benz	Veh. (B): 1990 Eagle
Type: C230, 4-door sedan	Type: Talon, 2-door hatchback
Driver: 42-year-old female	Driver: 29-year-old male
CDC: 12-FDEW-2, 09-LPEW-2	CDC: 99-0000-0

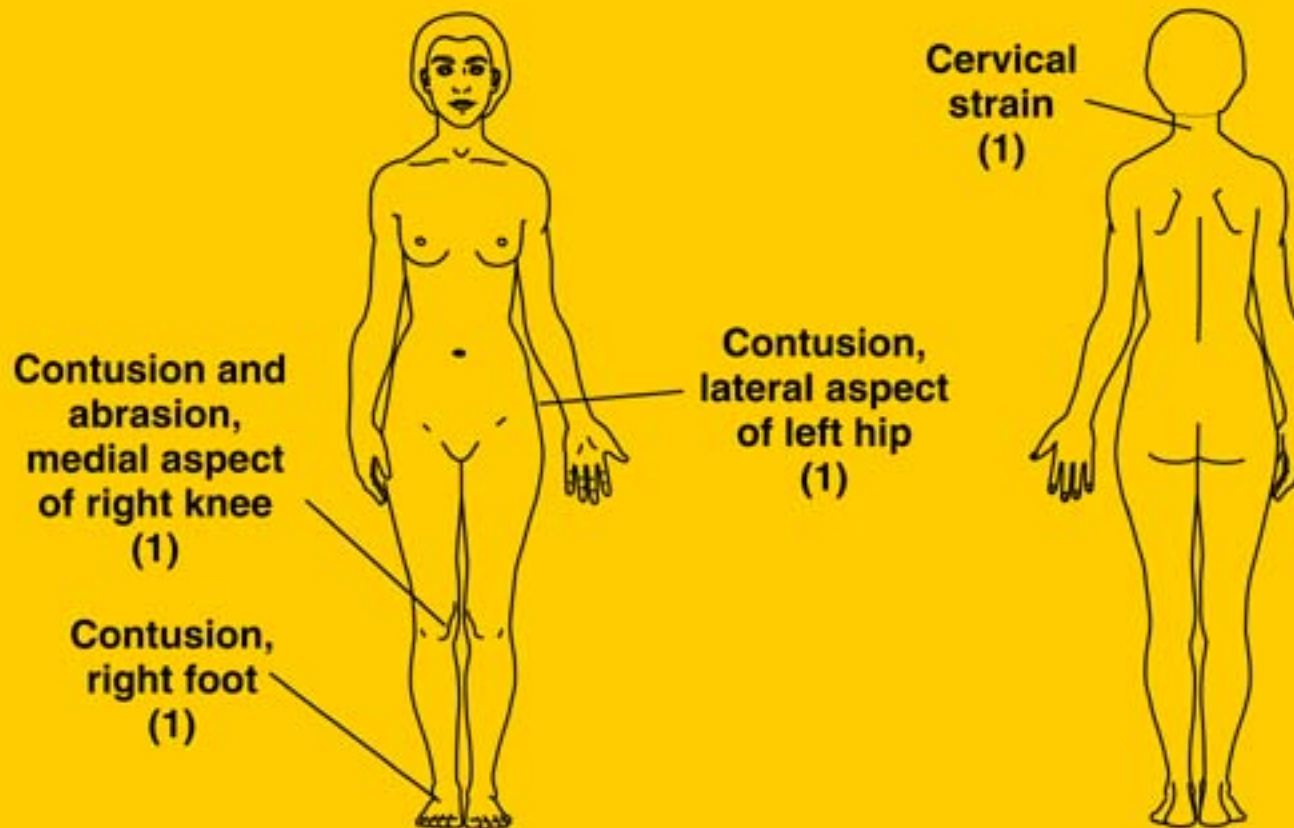
On impact, the driver moved forward and to the left relative to the vehicle interior, into the belt restraint and airbag. She sustained cervical strain, probably due to impact forces (flexion and/or lateral bending), or possibly due to head contact by the airbag. She sustained a contusion to her left hip, probably due to contact with the interior of the left-front side-door, or possibly due to loading by the lap belt. She sustained a contusion and abrasion to her right knee due to contact with the knee bolster, [46](#) as evidenced by a scuff mark just below the steering column. She sustained a contusion to her right foot, probably due to contact with the side of the brake pedal, or possibly due to contact with the toepan.

The following table and attached drawing [47](#) summarize the injuries for the driver of case vehicle (A).

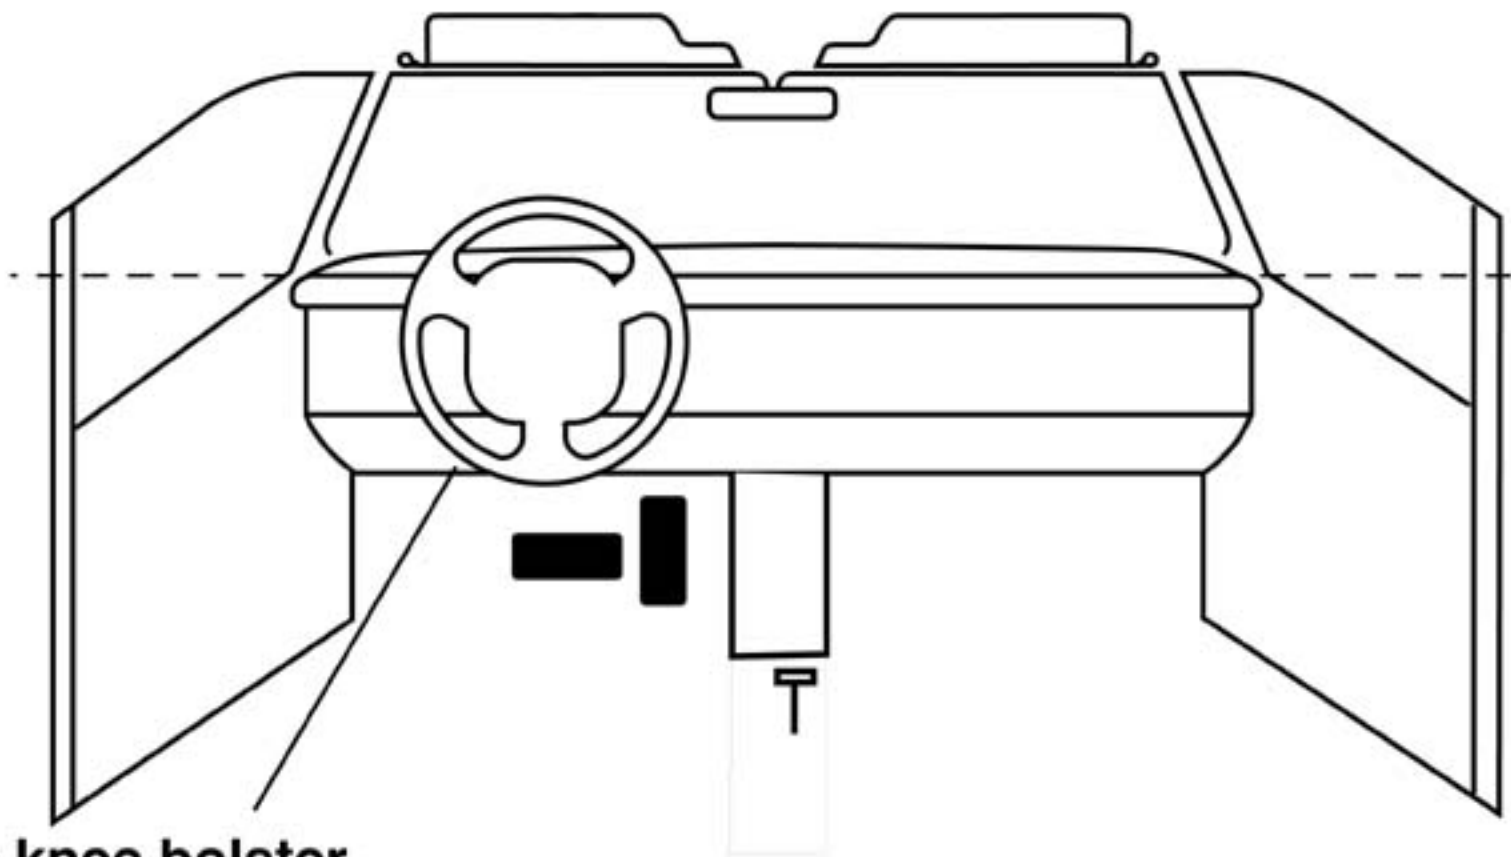
**A = knee bolster,  
scuff mark**
